Case Study

TOPIC: Water and Particulate Contamination In Steam Turbine Lube Oil Reservoir

LOCATION: Power Plant In Nursery, Texas

DATE: February 2, 2012

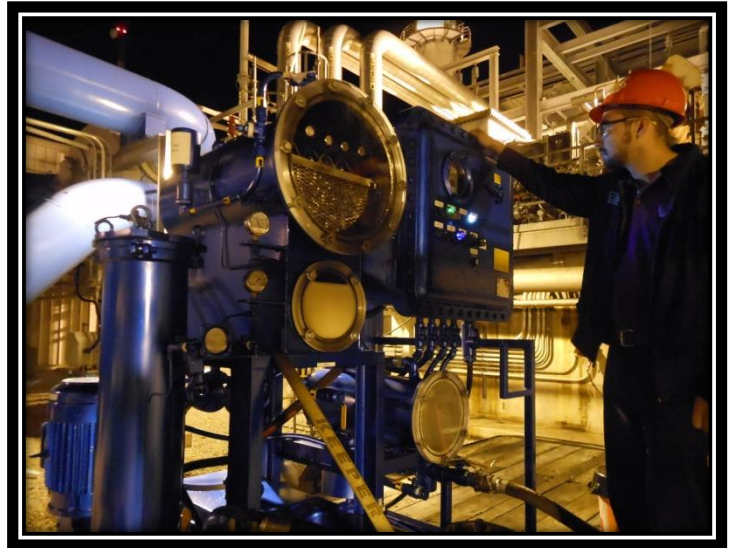
Solution: A VDOPS uses state-of-the-art filtration technology to lower water in oil concentrations in turbine oils to 45 PPM or lower. The system also uses the latest filtration media to lower particulate contamination to meet or exceed new oil cleanliness specifications, typically at ISO 16/13/10 or lower. The VDOPS systems are simple to operate and only use electricity to remove particulate, dissolved gases and water from oils. The systems are virtually maintenance free and are designed to run continuously 24/7 in any environment.

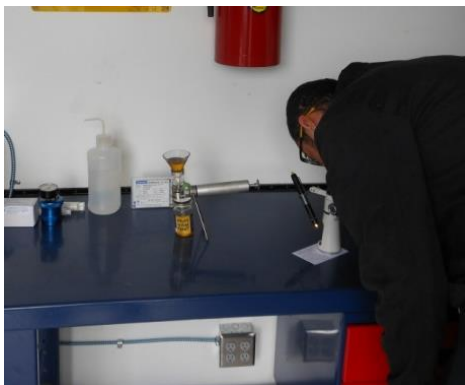
Results: Work started on Wednesday, February 1, and was completed on Friday, February 3. The VDOPS system ran for approximately 36 hours straight, while water levels dropped from over 6,000 PPM to under 45 PPM (see page four (4) for oil analysis water reduction graph). Particulate was lowered from 18/16/14 to 15/13/10; see page (3) for Particulate Removal / Oil Analysis Results. These results were verified by an on-sight Portable Fluid Analysis Kit (PFAK). The PFAK enabled our technicians to know how fast the system was cleaning the fluid and enabled the customer to visually see the results. This on-sight awareness brought confidence to STEC because they could also see the results in real-time and be part of the oil analysis process. STEC witnessed the system purifying the oil both by viewing the VDOPS in operation and also by an On-Sight Fluid Analysis Kit.

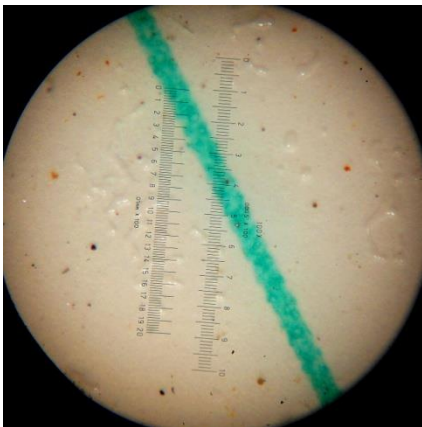
Pre-Filtration/Dehydration ISO Cleanliness Code

18-16-14

Particle Size

Range of Particles /ml

**>4mm
>6mm
>14mm**

**2,500-1,300
640-320
150-80**

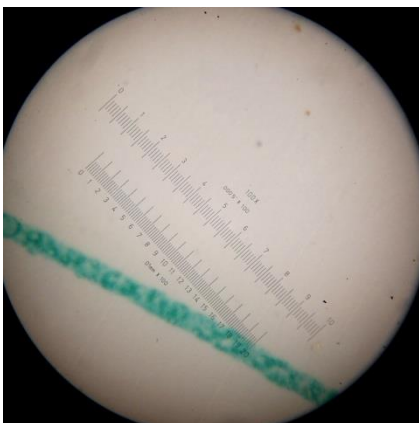
Final Sample ISO Cleanliness Code

15-13-10

Particle Size

Range of Particles /ml

**>4mm
>6mm
>14mm**

**320-150
80-40
20-10**
