CASE STUDY

TOPIC: Varnish Contamination In Large Hydraulic Shear

LOCATION: Salt Lake City, UT

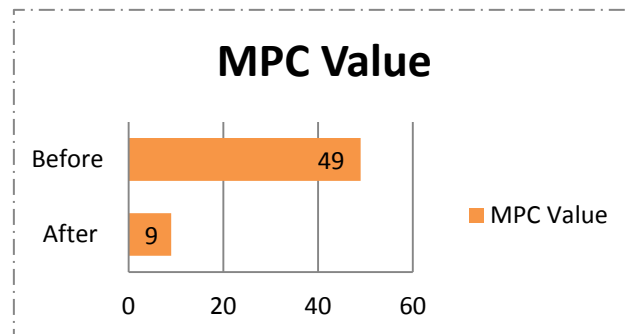
Results: The starting varnish content in the oil was MPC 49. After approximately 6 weeks of run-time, the varnish potential dropped significantly to MPC 9.

Solution: To effectively mitigate the varnish contamination in the hydraulic oil, the plant decided to implement a 10 GPM Varnish Removal System utilizing Granular Adsorbent Media and High Efficiency Beta>1000 Filter Elements to re-circulate the reservoir in a kidney-loop configuration, continuously removing impurities as the hydraulics of the Shear were actuated.
