Case Study

TOPIC: Water and Particulate Contamination In Steam Turbine Lube Oil Reservoir

LOCATION: Power Plant In Nursery, Texas

DATE: February 2, 2012

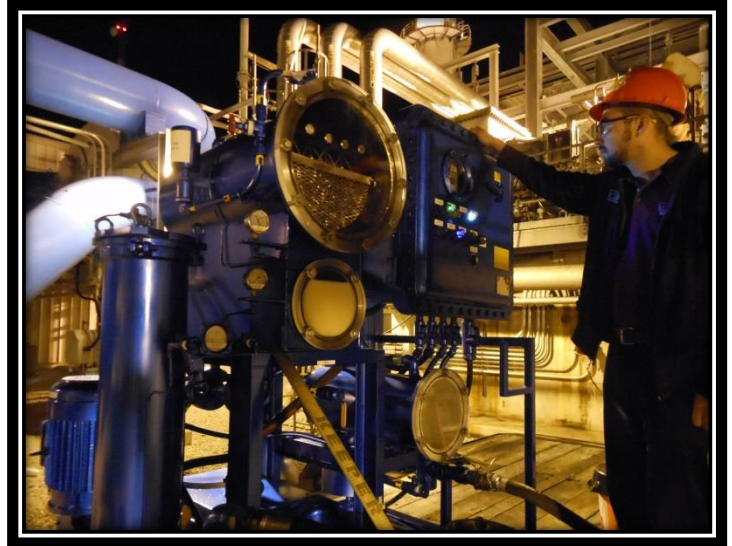
Solution: A VDOPS uses state-of-the-art filtration technology to lower water in oil concentrations in turbine oils to 45 PPM or lower. The system also uses the latest filtration media to lower particulate contamination to meet or exceed new oil cleanliness specifications, typically at ISO 16/13/10 or lower. The VDOPS systems are simple to operate and only use electricity to remove particulate, dissolved gases and water from oils. The systems are virtually maintenance free and are designed to run continuously 24/7 in any environment.

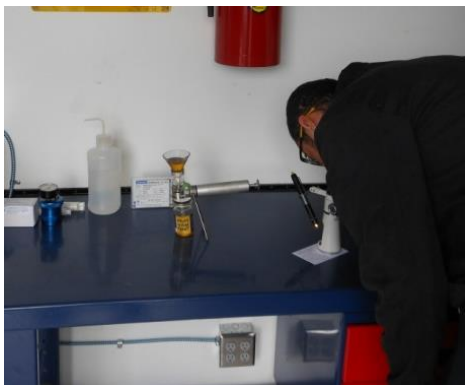
Results: Work started on Wednesday, February 1, and was completed on Friday, February 3. The VDOPS system ran for approximately 36 hours straight, while water levels dropped from over 6,000 PPM to under 45 PPM (see page four (4) for oil analysis water reduction graph). Particulate was lowered from 18/16/14 to 15/13/10; see page (3) for Particulate Removal / Oil Analysis Results. These results were verified by an on-sight Portable Fluid Analysis Kit (PFAK). The PFAK enabled our technicians to know how fast the system was cleaning the fluid and enabled the customer to visually see the results. This on-sight awareness brought confidence to STEC because they could also see the results in real-time and be part of the oil analysis process. STEC witnessed the system purifying the oil both by viewing the VDOPS in operation and also by an On-Sight Fluid Analysis Kit.

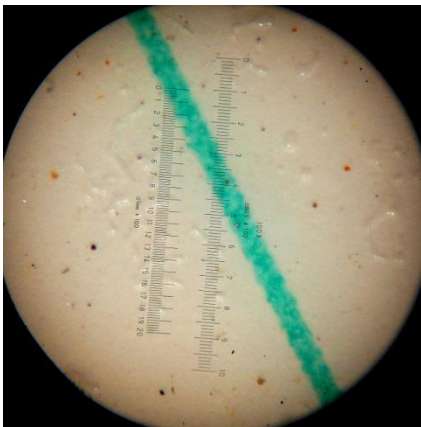
Pre-Filtration/Dehydration ISO Cleanliness Code

18-16-14

Particle Size

Range of Particles /ml

>4mm
>6mm
>14mm

2,500-1,300
640-320
150-80
